ACCIDENT AT STM on 15th May 2016

SUMMARY OF ACCIDENT

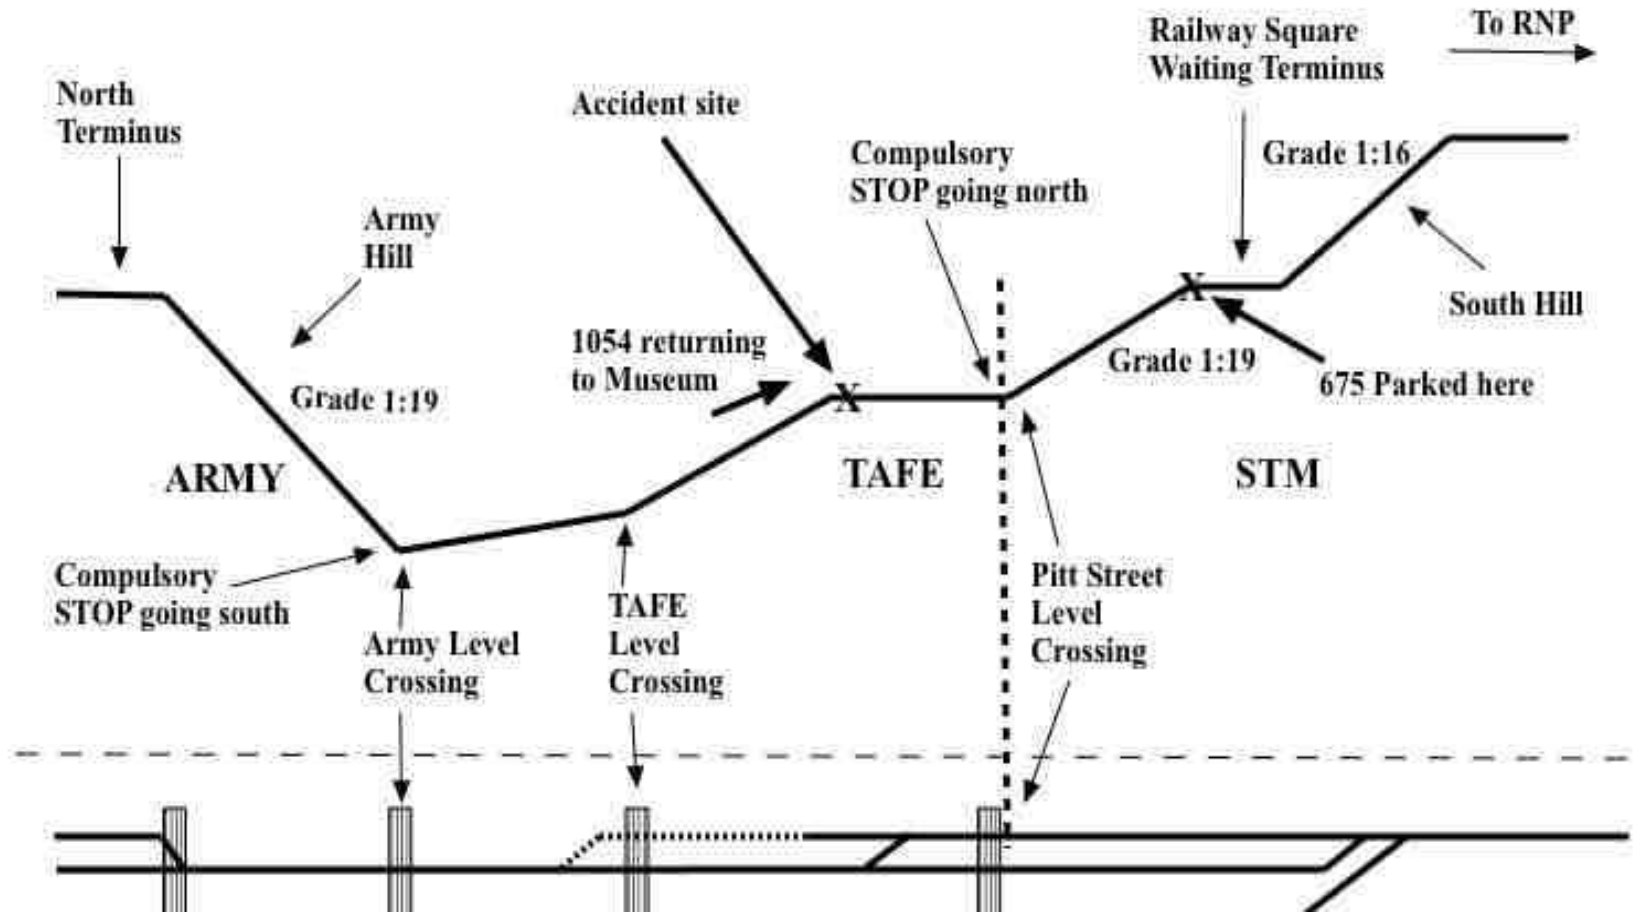
ACCIDENT SITE

- Sydney J class tramcar 675 was parked at Railway Square terminus – left unattended
- Brakes were applied and tram chocked
- Its brakes leaked off, chock pushed aside and it rolled away
- Japanese Nagasaki tramcar 1054 was returning from North terminus with 15 passengers and 2 crew
- Both collided north of the Pitt Street level crossing.

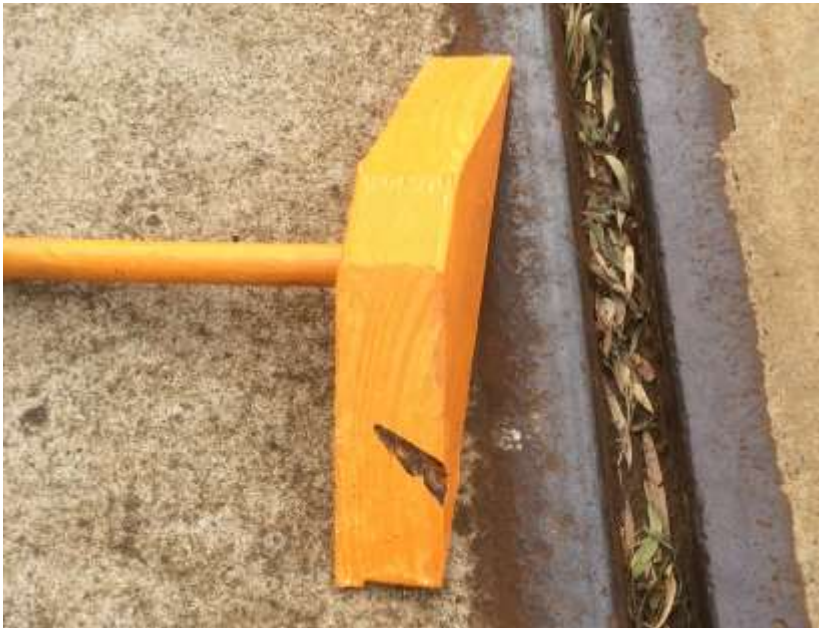
- Air brakes leaked off 675
- Chocks not properly placed under wheels
- Wrong way

- Ban use of triangular chocks
- Develop a standard details of chock
- Develop procedures for chocking trams
- All trams to be chocked and handbrakes applied when parked
- Retrain all crews in the correct procedure for chocking trams and applying the handbrakes
- Ensure at least 1 crewmember is near the trams at Railway Square Waiting Shed AT ALL TIMES
- All trams travelling NORTH on Tramway Avenue are not to exceed walking pace or 4kph
