Issues of Heritage Trams in the Streets

A Christchurch perspective

Dave Hinman September 2018

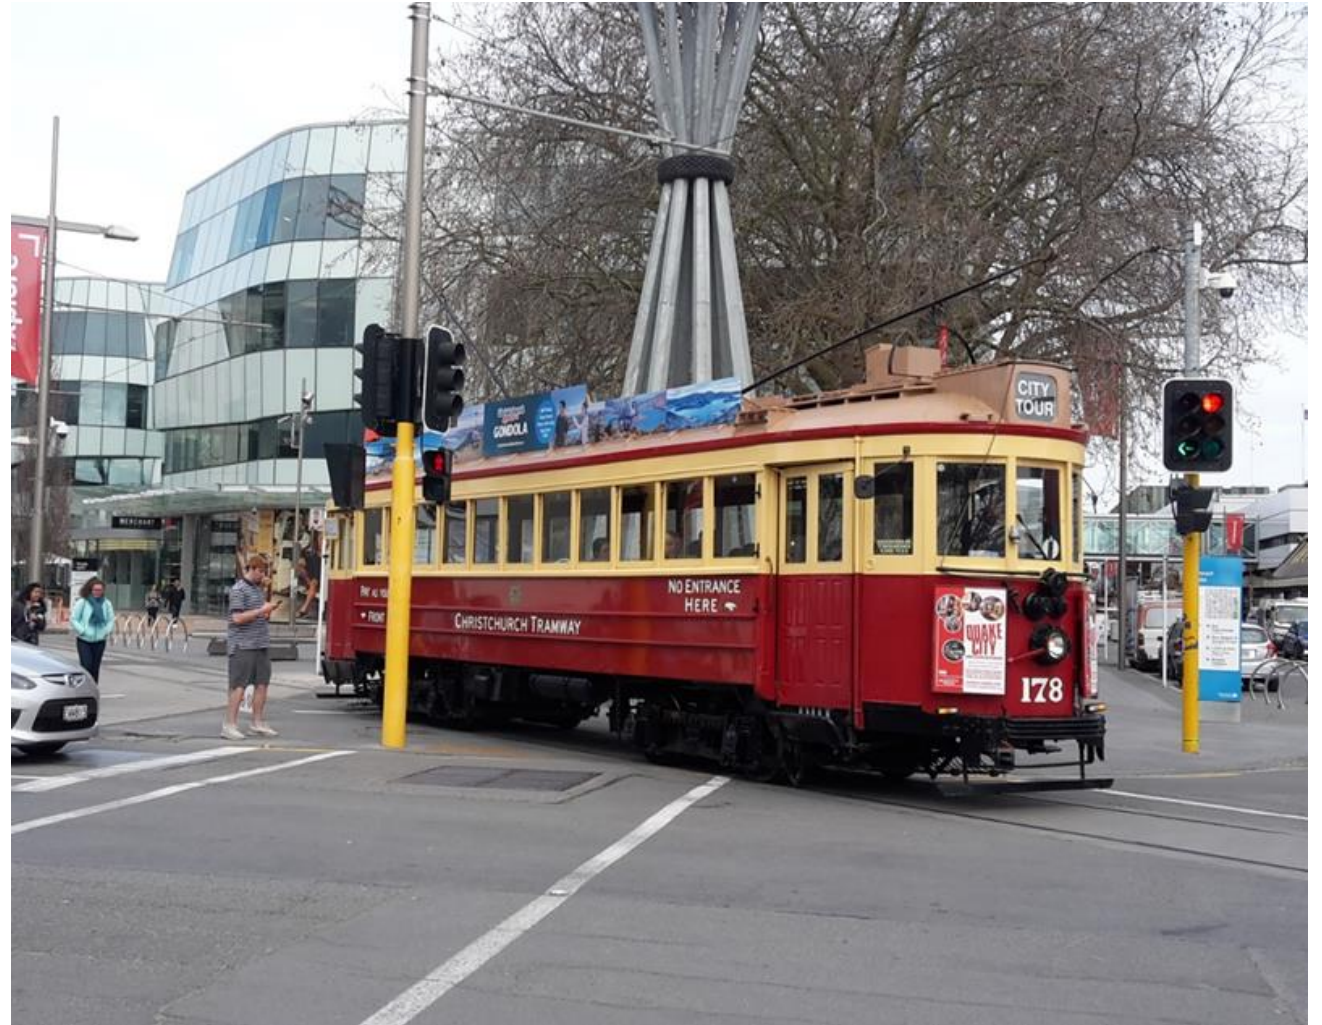
Vehicles - restored and well presented – in good operating condition fit for *daily* operation (unlike most heritage trams in a museum situation).

Safety glass throughout, rewiring, crack testing, and .. Some basic features to suit modern traffic conditions added, including low voltage circuits for some lighting and comms.

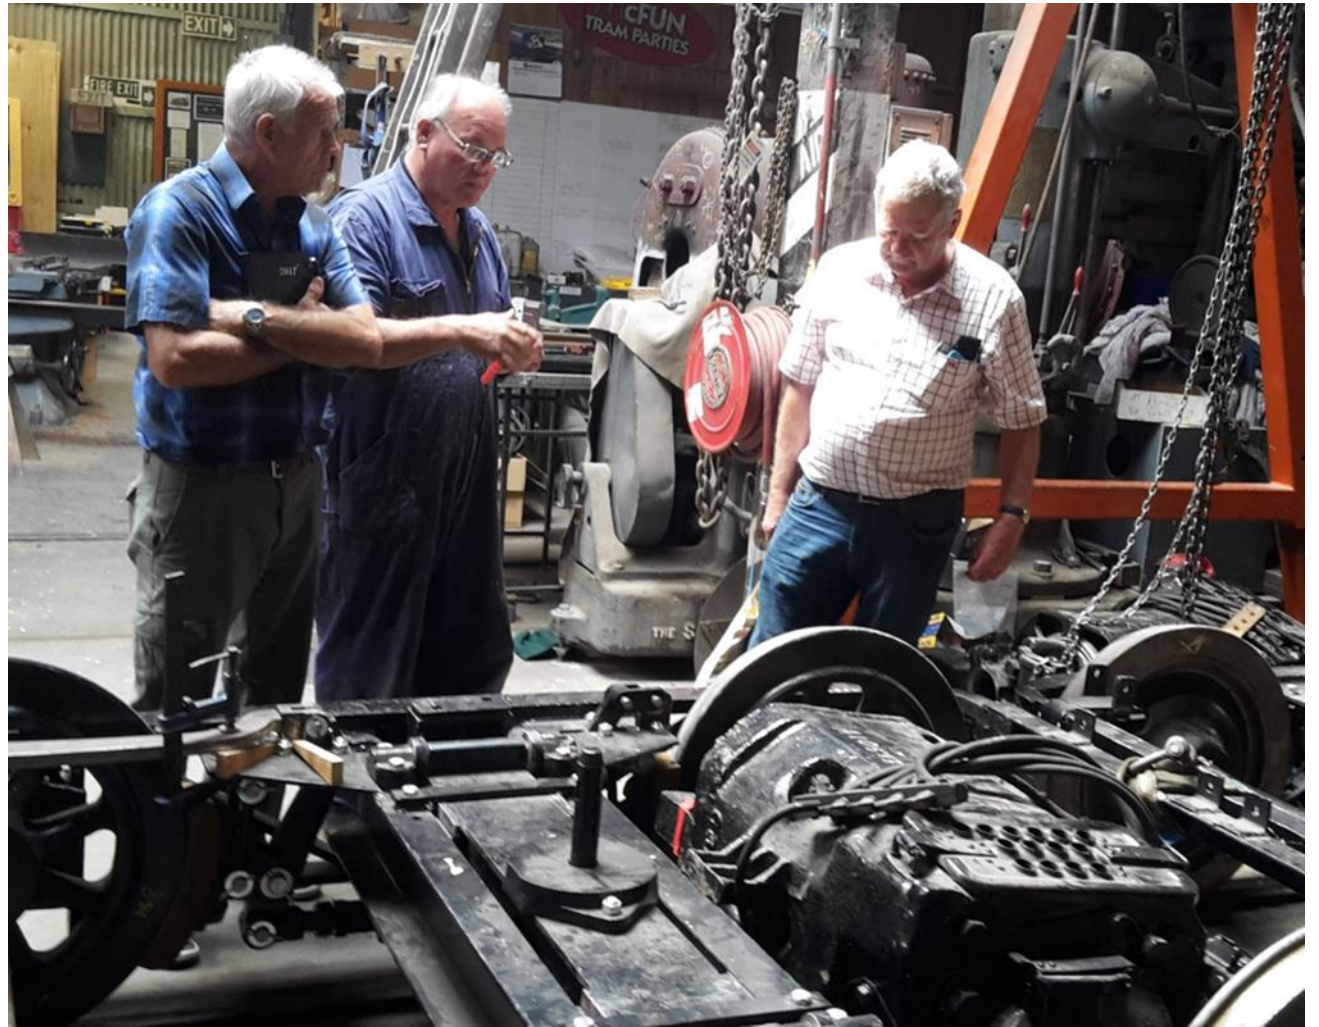
Truck manufacture at Ferrymead – for Sydney Tramway Museum

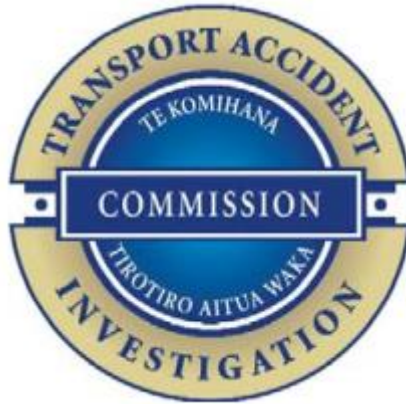
06-112 Report 06-112, loss of airbrakes and collision, Tram 244,

Good safety record - only one instance of TAIC involvement – 244 brake failure in 2006 - cars damaged, but no injuries!

RAILWAY OCCURRENCE REPORT

November 2006 Christchurch

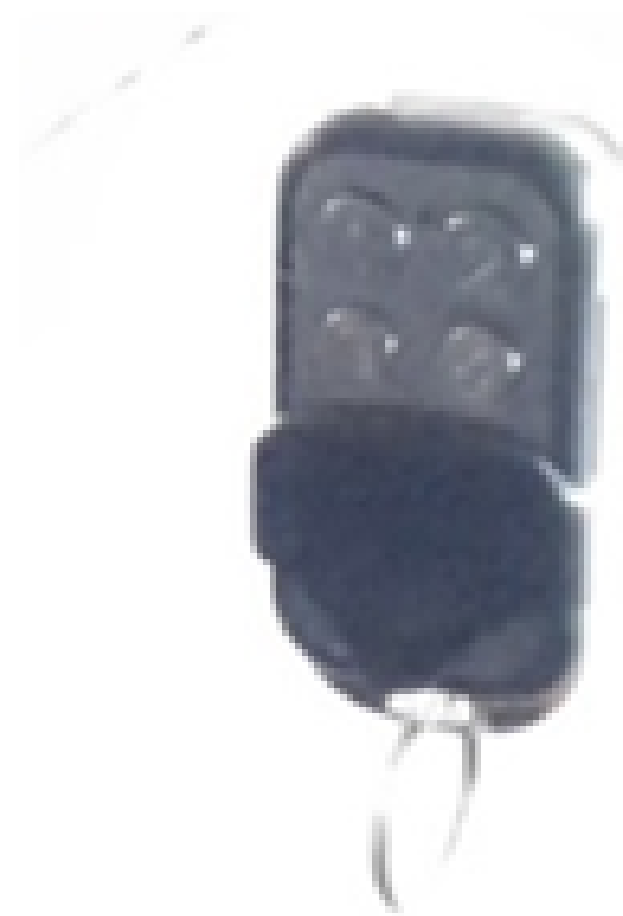
All trams are fitted with a 24-volt system for marker lights, tail lights, indicators, radios, etc. Battery to ensure that these systems still operate if the power fails or the trolley pole leaves the wire.

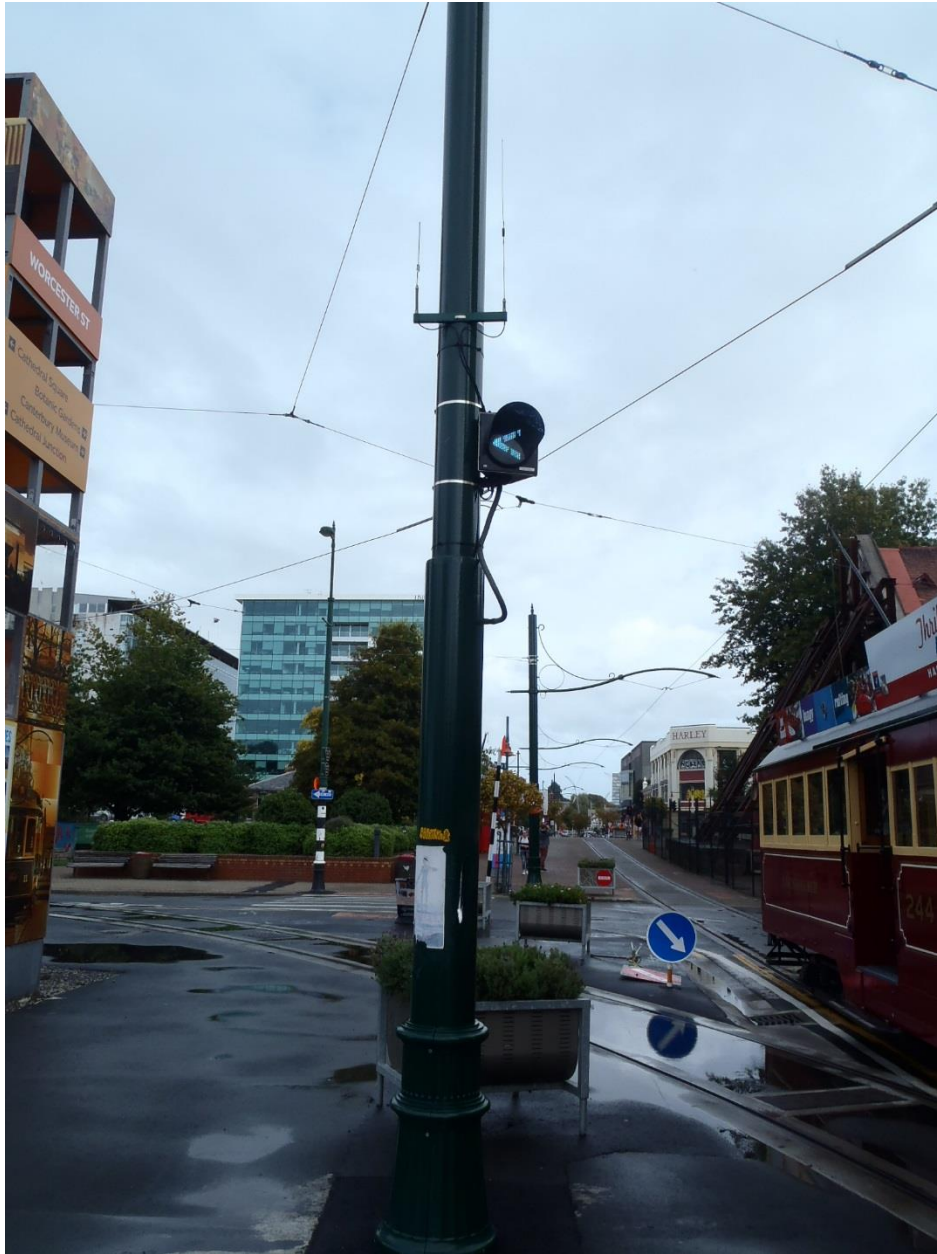
Junction of Worcester Bld and Oxford Tce - driver remotely changes points, signal shows direction, wheel counters.

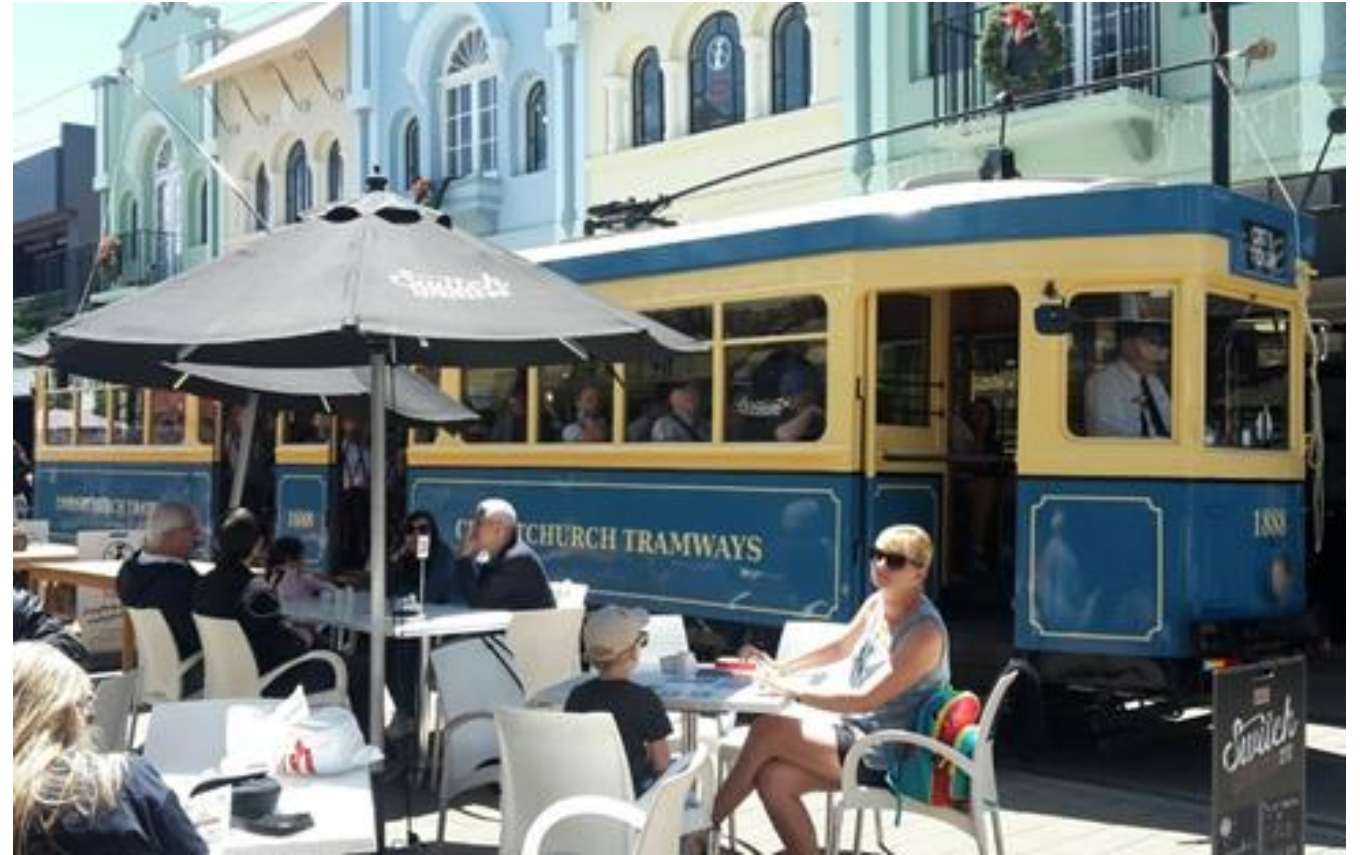
Trolley poles v Pantographs

Poles should not be an issue if overhead is well constructed and maintained and in Christchurch slow speeds also reduce risks of de-wiring.

Drivers also at less risk in quiet or no traffic streets. New loop is modern “elastic” K&M and used by poles.

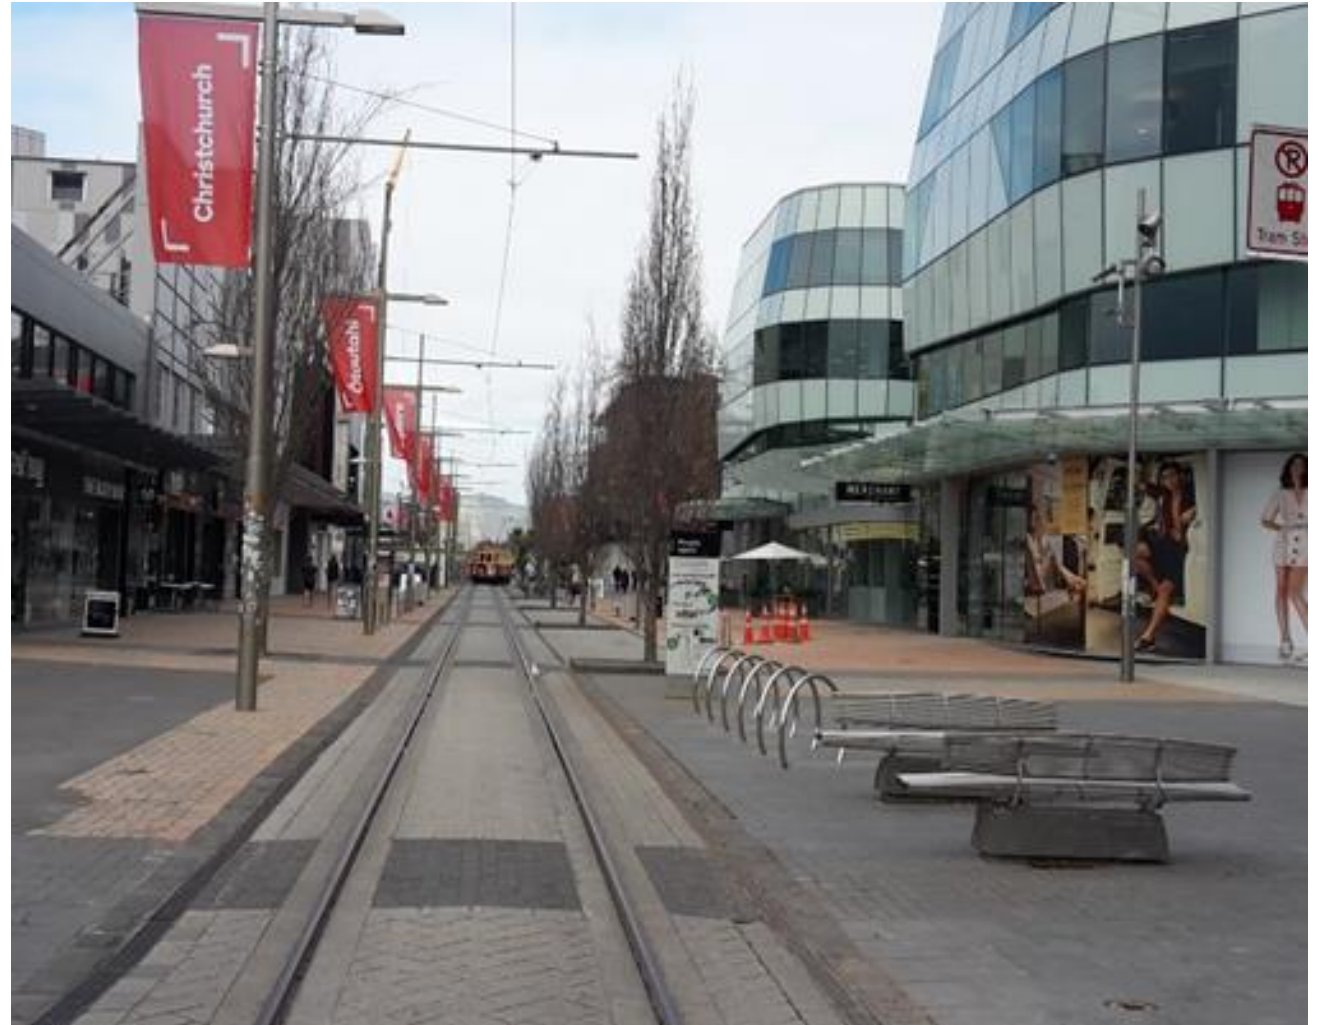
Post earthquake re-opening issues – “some over zealous, extremely safety conscious risk averse officials” re. tram travelling in both directions on single line required massive cross hatching – in case someone wasn’t aware tram might be coming “backwards”.

Yellow now mostly removed – at considerable expense!

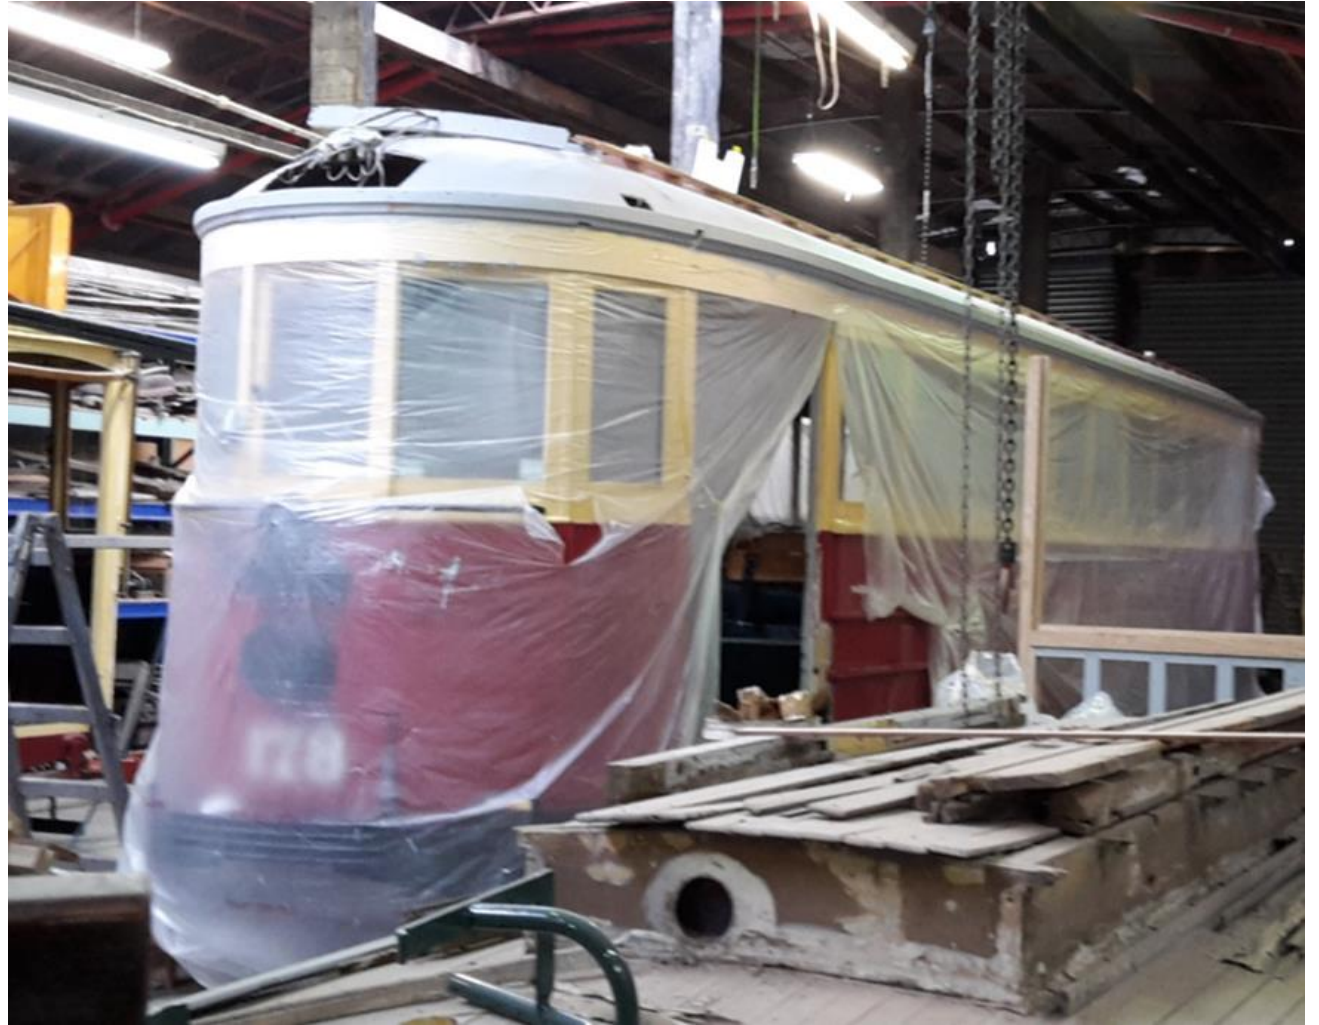
178 – major roof repairs at
Ferrymead Tramway 2018
