## TRAM AND RAILWAY CARRIAGE ROOF COVERINGS

*Chaired by Les Stewart, Wellington Tramway Museum*

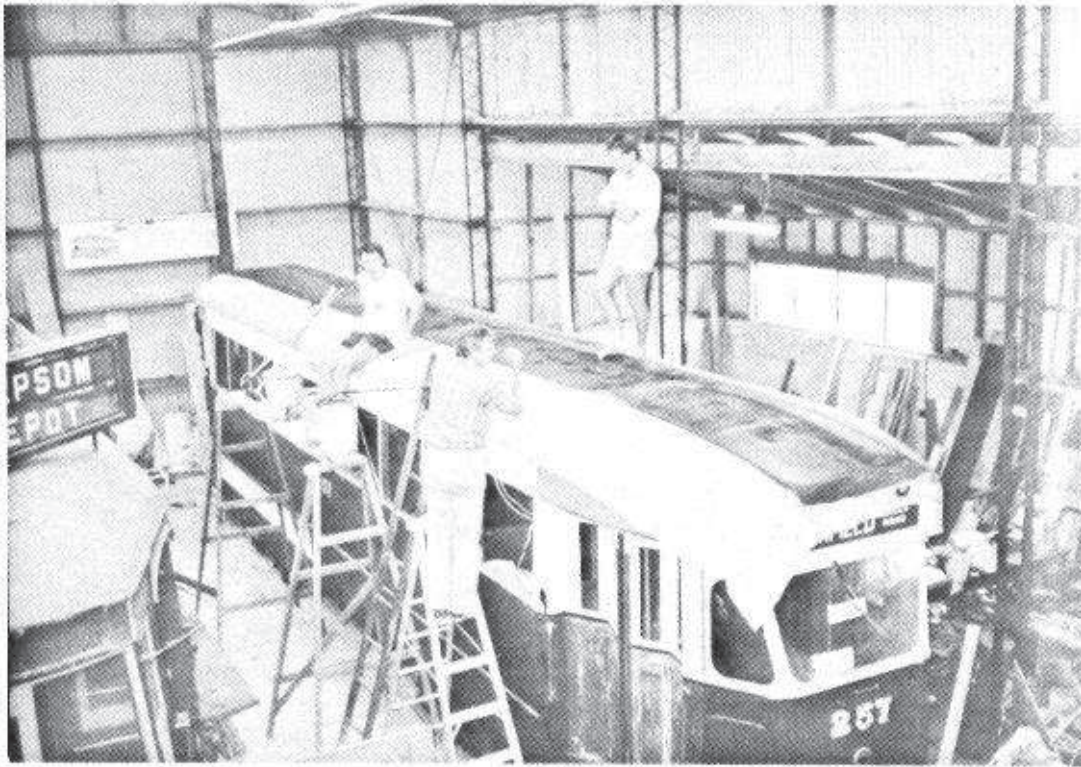
Laying butyl rubber on the roof of Fiducia 257 at MOTAT. *Photograph: Ian Stewart.*

On Fiducia 257, two lengths of mid-grey, 1.5mm butyl rubber were laid with a 70mm lap down the centre-line of the roof. A special lap tape was used to ensure the roof was completely weather tight. The roof on this tram is a

mixture of plywood, curved sheet metal and wooden battens. Good adhesion was ensured by giving all areas a priming coat of diluted contact adhesive well before the final stage. No problems were found where it was necessary to stretch the sheet slightly at the tight compound curves over the cabs. The final appearance is indistinguishable from canvas.
